**DISASSEMBLY OF A NEXSTAR GPS-11 MOUNT**  
by Bob Buchheim (rbuchheim@earthlink.net)  
Altimira Observatory ([http://www.geocities.com/oca\\_bob](http://www.geocities.com/oca_bob))

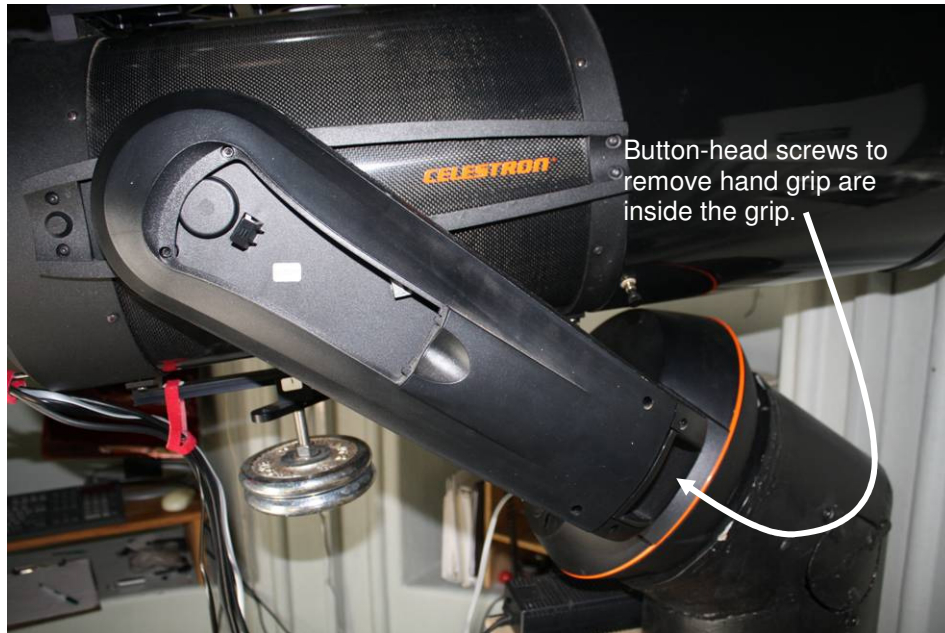
The West fork arm is shown in Figure 3. I removed its plastic covers in the following order: first the top (long) cover, then the lifting hand grip, and finally the lower plastic cover (a U-shaped plastic piece that fits around the hand grip). The lifting hand grip is metal, and it uses button-head screws instead of the socket-cap screws that are used on all of the plastic covers.

**Figure 3: West fork arm**

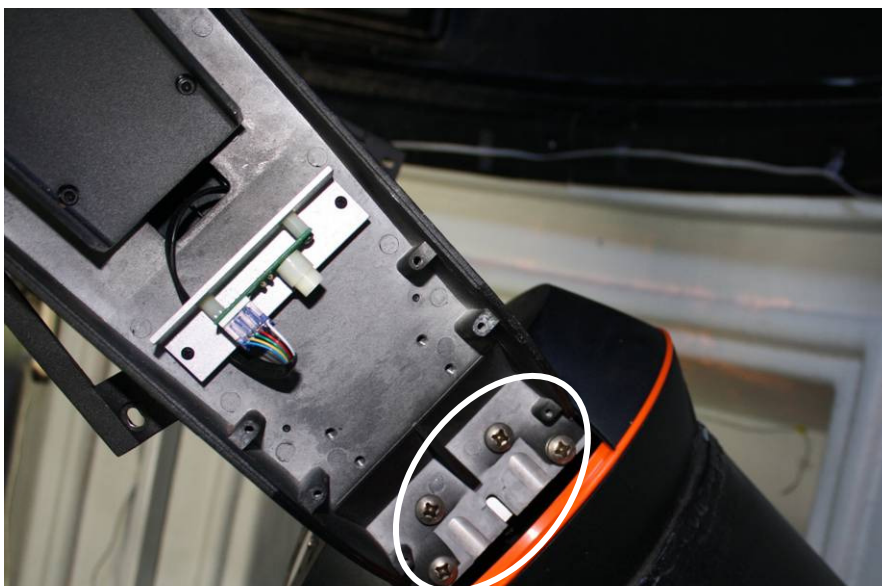
Figure 4 shows what the West fork arm looks like with the covers removed. Note the four large Phillips-head screws at the base of the arm (lower right in the photo). As on the East arm, I gave each in turn a little CCW torque, and then re-tightened it. Breaking the stiction at this point will make it easier to loosen them when the time comes. But don't loosen them yet!

**Figure 4: West fork arm after covers are removed**

This means that when you remove the 8 screws holding the OTA (4 on each side), the OTA won't come loose – it is still captured by the pins (one on each side). In order to disengage the pins, you loosen the 8 big Phillips-head screws shown previously in Figures 3 and 4. The idea is to spread the fork arms sufficiently (about 1/4 - 1/2 inch on each side), that you can slip the OTA pins out of the Declination brackets. This is a two- or three-person job. With three people, it's pretty easy: I held the OTA, neighbor #1 loosened the big screws at the base of the East arm and pulled it a bit, while neighbor #2 loosened the screws on the West fork arm to spread it. Since you're trying to spread the fork arms, you need to loosen the upper screws more than the lower screws. I didn't completely remove them, so I don't know what happens if you do – I

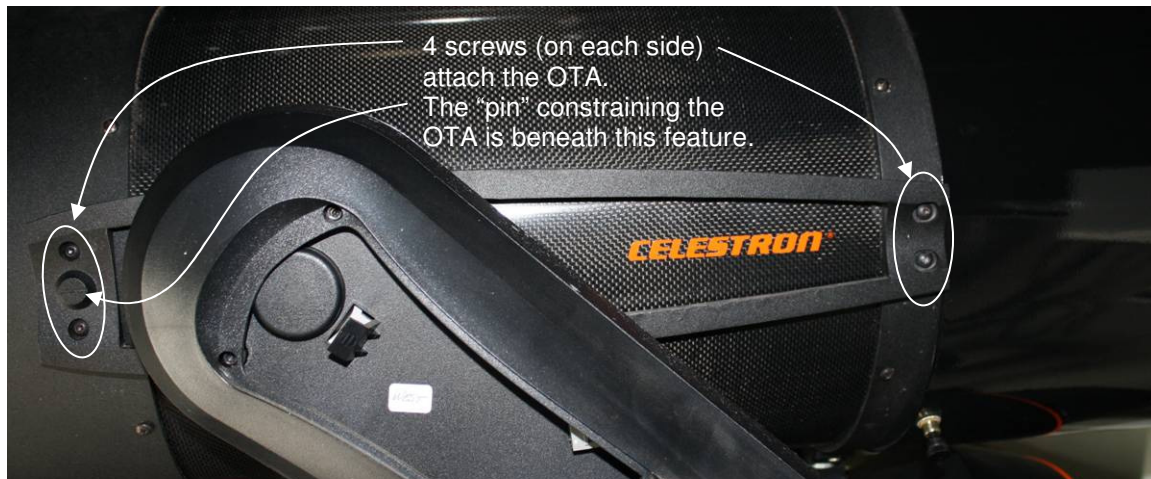
The Optical Tube Assembly (OTA) is attached to the Declination axis brackets by four screws on each side, as shown in Figure 5.

**Figure 5: Bracket holds the Optical Tube Assembly**

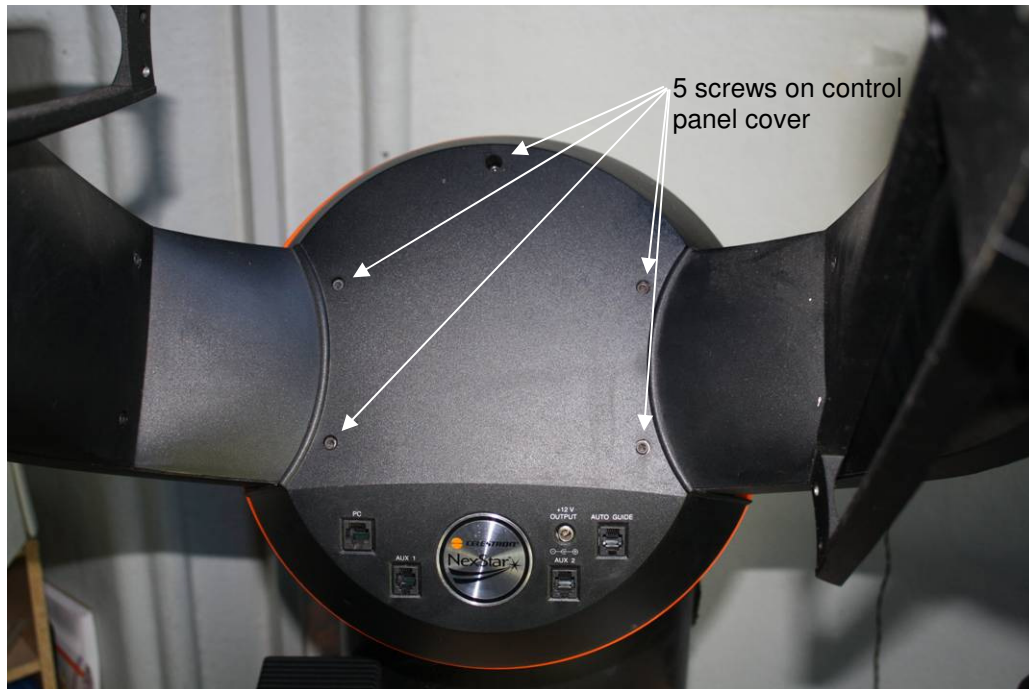
4.2 Opening the control panel cover: The control panel cover is shown in Figure 8. There are five cap-head screws securing the plastic cover. Remove all of them. Note that the one at top is shorter than the other four (this will be important when you're putting it back together). With the 5 screws removed, you can lift the plastic control panel up and toward the East (left) fork arm (i.e. like a lid being opened). I watched carefully from underneath so that I wouldn't pull any wires. What you'll see at this point is shown in Figure 9.

**Figure 8: Control panel cover**
